Information for the users of the Petzl ZIGZAG

May 19, 2014

April 08, 2014

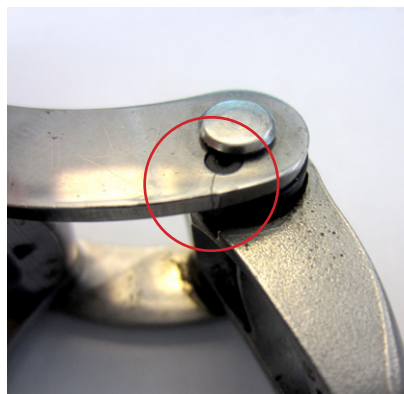
Two different customers have informed us of the presence of a crack on one of the ZIGZAG's steel chain links. Both units have been returned to Petzl for analysis.

A cracked link presents no additional risk to the user. However, the presence of such a crack requires immediate retirement of the ZIGZAG.

- Regularly inspect your ZIGZAG in accordance with the ZIGZAG PPE checking procedure.
- In the unlikely event you find a cracked link, retire your ZIGZAG immediately and contact your local Petzl distributor for a replacement under warranty.
- A cracked link presents no additional immediate risk to the user. However, like for any PPE , the presence of such a crack requires immediate retirement of the ZIGZAG.
- These recommendations therefore apply also to the Petzl ZILLON.

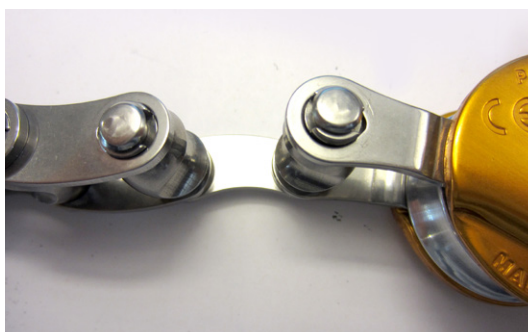
14 kN

we intentionally cut one of the steel links in the ZIGZAG friction chain and performed tensile tests. We cut the link located at the bottom of the chain, as those links are subject to the greatest force.

- The cut link failed at 14 kN, resulting in deformation of the opposite link. However, the chain always remained connected to the body of the ZIGZAG. The same test on an upper link intentionally cut (same damage as one of the two returned cracked ZIGZAG) leads to the same result.

- In a dynamic suspension, the cut link is deformed but not broken (see photos below).
